Recreational Use Attainability Analysis for Buffalo Creek (0214B), Paradise Creek (0230A), and Sweetwater Creek (0299A) in the Red River Basin

DRAFT for PUBLIC REVIEW

Prepared for:
Texas State Soil and Water Conservation Board
Project 12-52

TR 1308

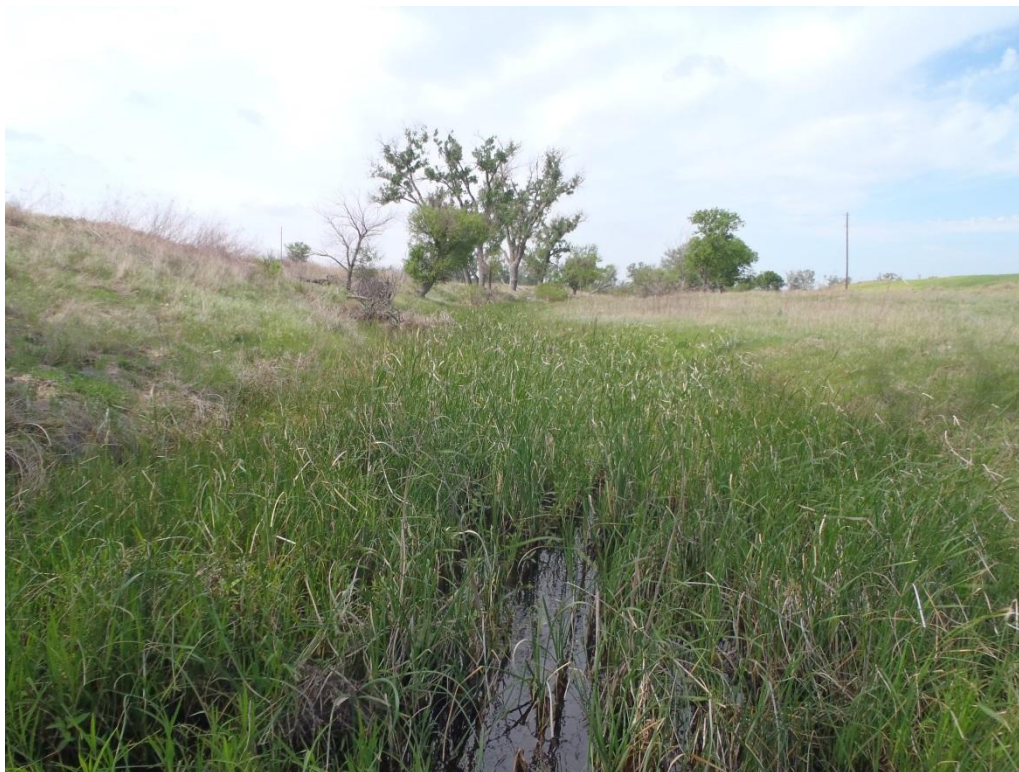
Figure 5.67 Photograph of Sweetwater Creek Site SW027 taken on May 28, 2013, the upstream view of the 30-m transect.

Site SW027 was wadeable for the entire 300-m reach length, although thick vegetation made traversing the stream channel challenging (Figures 5.67 and 5.68). One pool was identified during the first survey that was 30 meters long, 11 meters wide and had a maximum depth of 1.6 meters. Average thalweg was 0.18 m during the first survey and 0.08 m during the second survey (Table 5.6). During both surveys, the vegetation and sludge bottom deposits made walking in the stream channel challenging despite the sand dominant substrate. TIAER personnel would typically walk along the bank and forge a path through the vegetation at each transect to obtain depth measurements and photographic documentation of conditions. Widths of the stream ranged from a maximum of 20 m to a minimum of 1.4 m both encountered during the second survey (Tables 5.7 and 5.8). Thick vegetation and one log jam were the only obstructions encountered throughout the reach during both surveys.

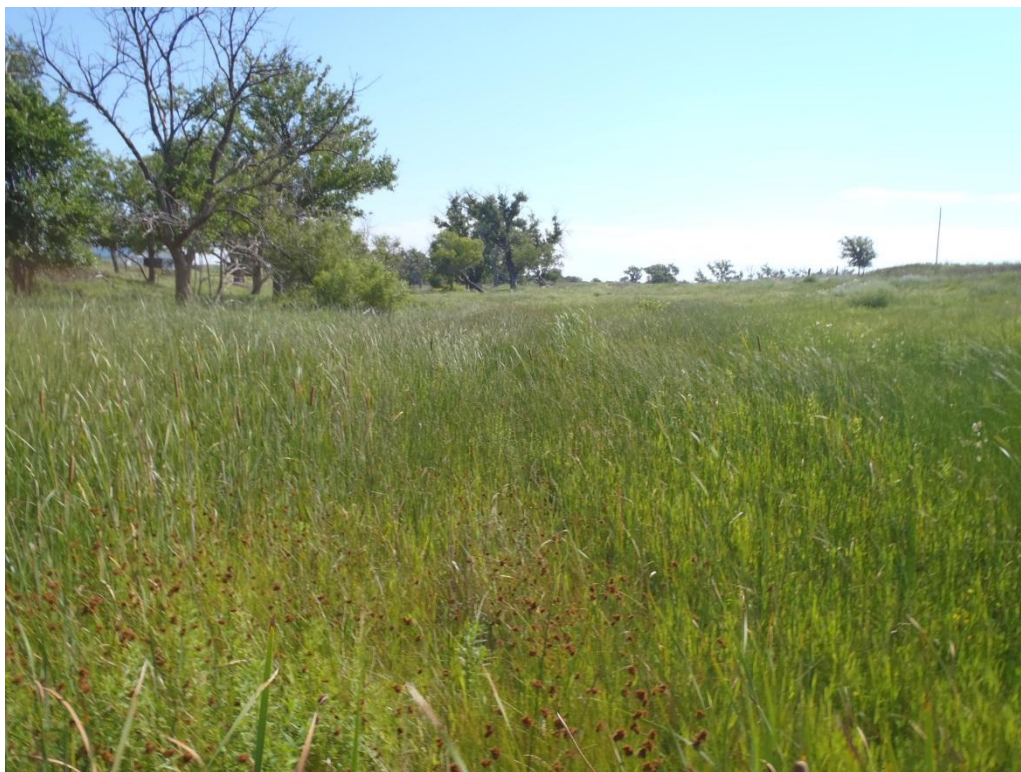
Figure 5.68 Photograph of Sweetwater Creek Site SW027 taken on July 28, 2013, the downstream view of the 300-m transect.

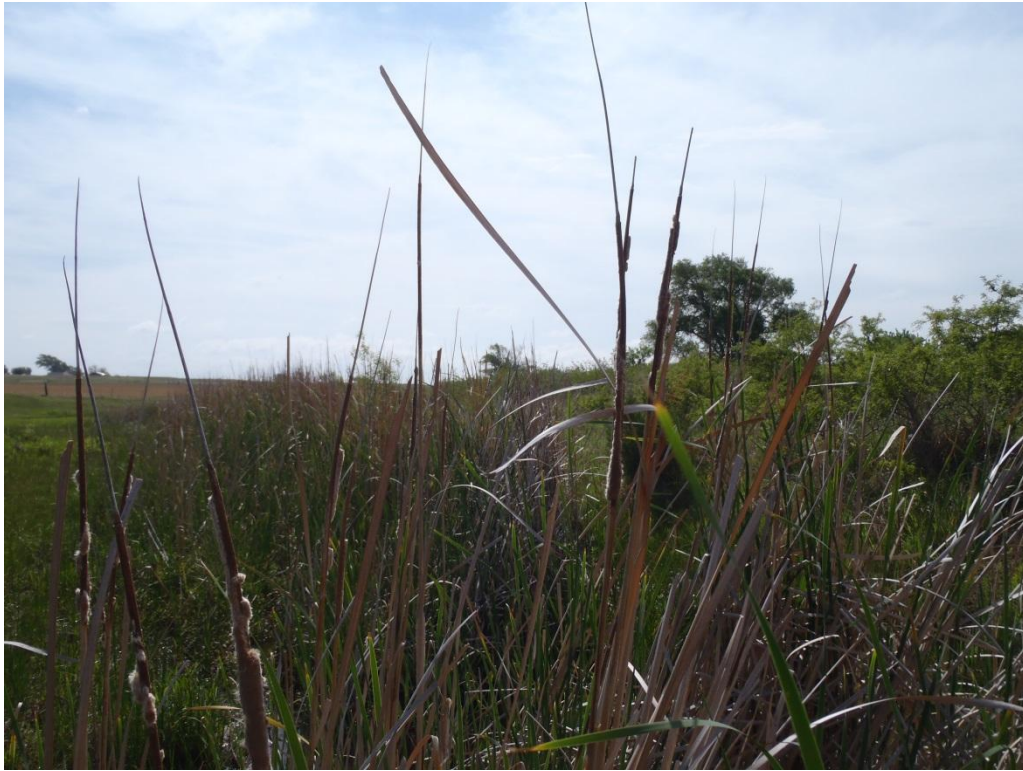
Figure 5.69 Photograph of Sweetwater Creek Site SW028 taken on May 28, 2013, the downstream view of the 150-m transect.

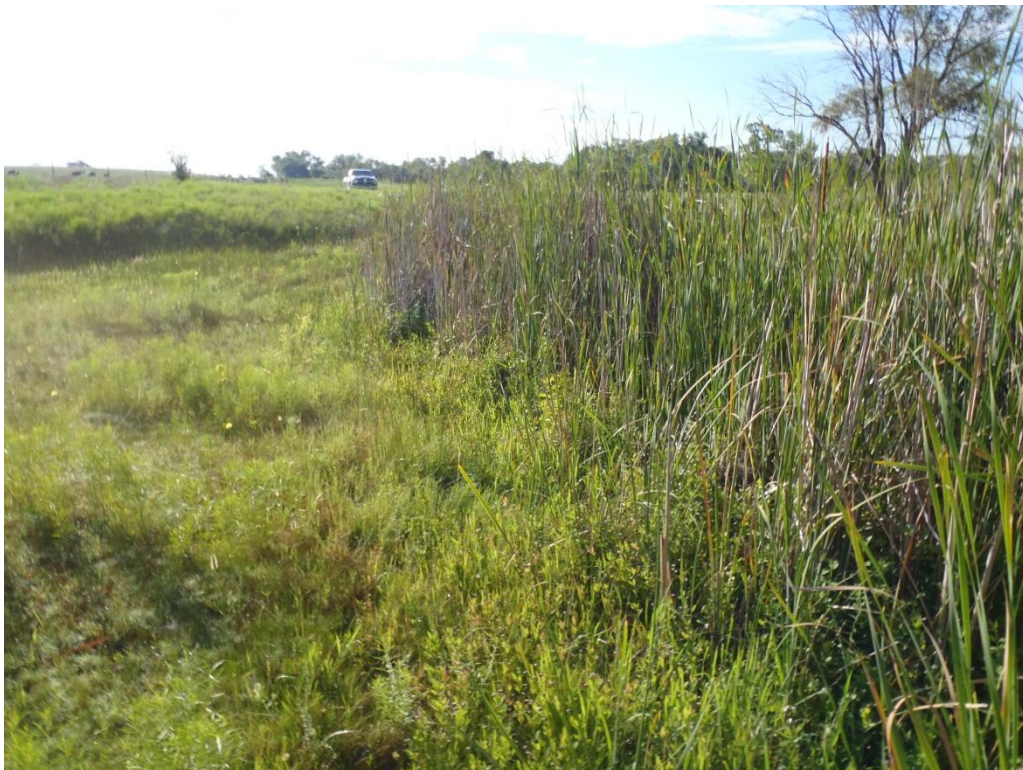
Figure 5.70 Photograph of Sweetwater Creek Site SW028 taken on July 28, 2013, the downstream view of the 30-m transect. TIAER truck in photograph.

Site SW028 was wadeable for the entire 300-m reach length, although thick vegetation made traversing the stream channel challenging (Figure 5.99 and 5.70). No pools were identified during either survey. Average thalweg was 0.33 m during the first survey and 0.19 m during the second survey (Table 5.6). During both surveys, the vegetation and sludge bottom deposits made walking in the stream channel challenging despite the sand dominant substrate. TIAER personnel would typically walk along the bank and forge a path through the vegetation at each transect to obtain depth measurements and photographic documentation of the conditions. Widths of the stream ranged from a maximum of 14 m during the first survey to a minimum of 0.0 m during the second survey when the stream was not flowing (Tables 5.7 and 5.8). Thick vegetation was the only obstruction encountered throughout the reach during both surveys.

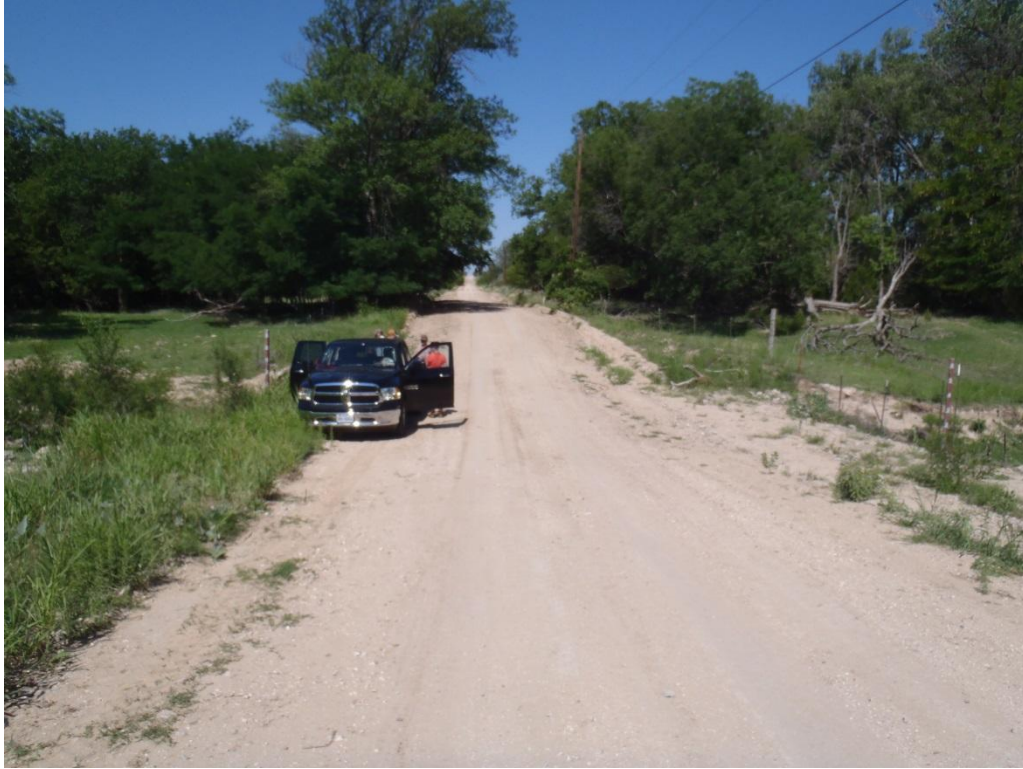
Figure 5.71 Photograph of Sweetwater Creek Site SW029 taken on July 28, 2013 showing public accessibility at the road. TIAER truck and personnel in photograph.

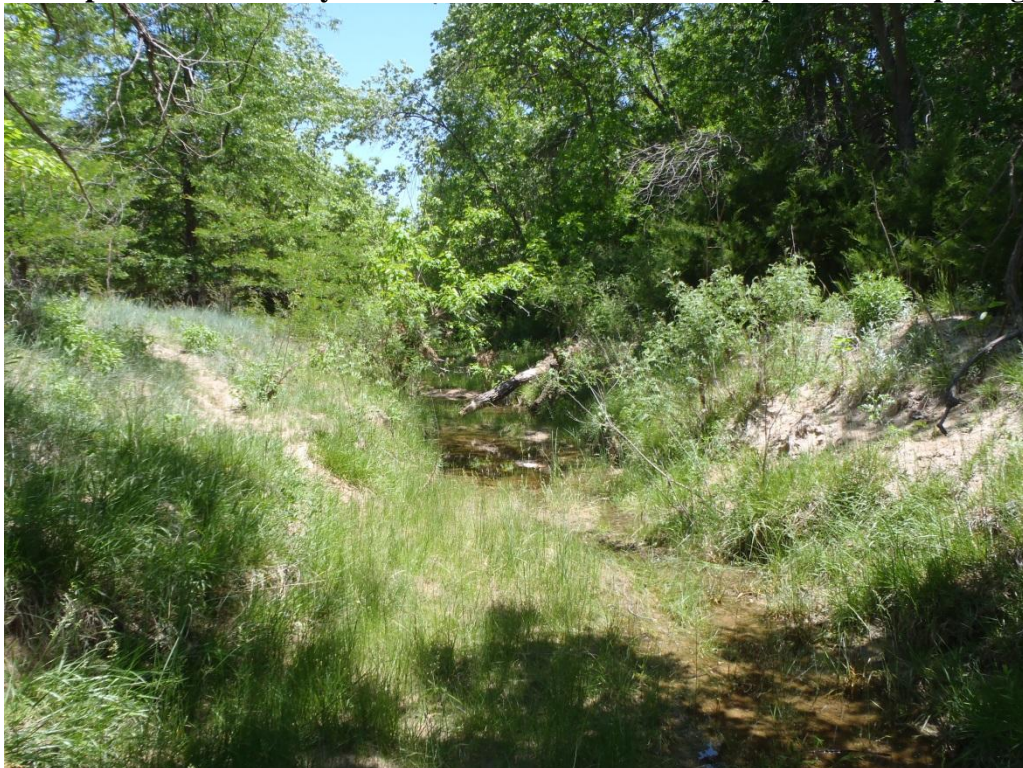
Site SW029 was wadeable for the entire 300-m reach length. Although water was present in pockets throughout the reach, no pools were identified during either survey with maximum water depths of only 0.25 meters. Average thalweg was 0.03 m during the first survey and 0.0 m during the second survey (Table 5.6). During both surveys, the sand dominant substrate made traversing the stream channel easy. Widths of the stream ranged from a maximum of 4.5 m during the first survey to a minimum of 0.0 m during the second survey (Tables 5.7 and 5.8). The stream was not flowing during either survey. One tree obstruction was encountered within the reach during both surveys.

Figure 5.72 Photograph of Sweetwater Creek Site SW029 taken on May 27, 2013, the upstream view of the 150-m transect.

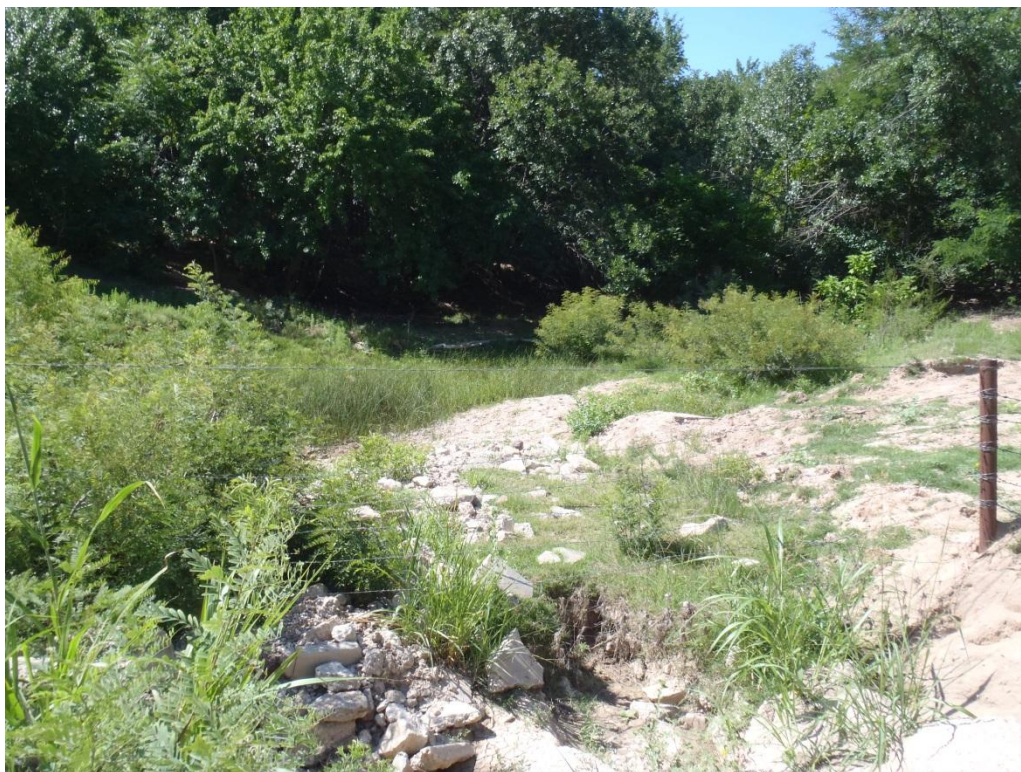
Figure 5.73 Photograph of Sweetwater Creek Site SW029 taken on July 28, 2013, the downstream view of the 300-m transect.

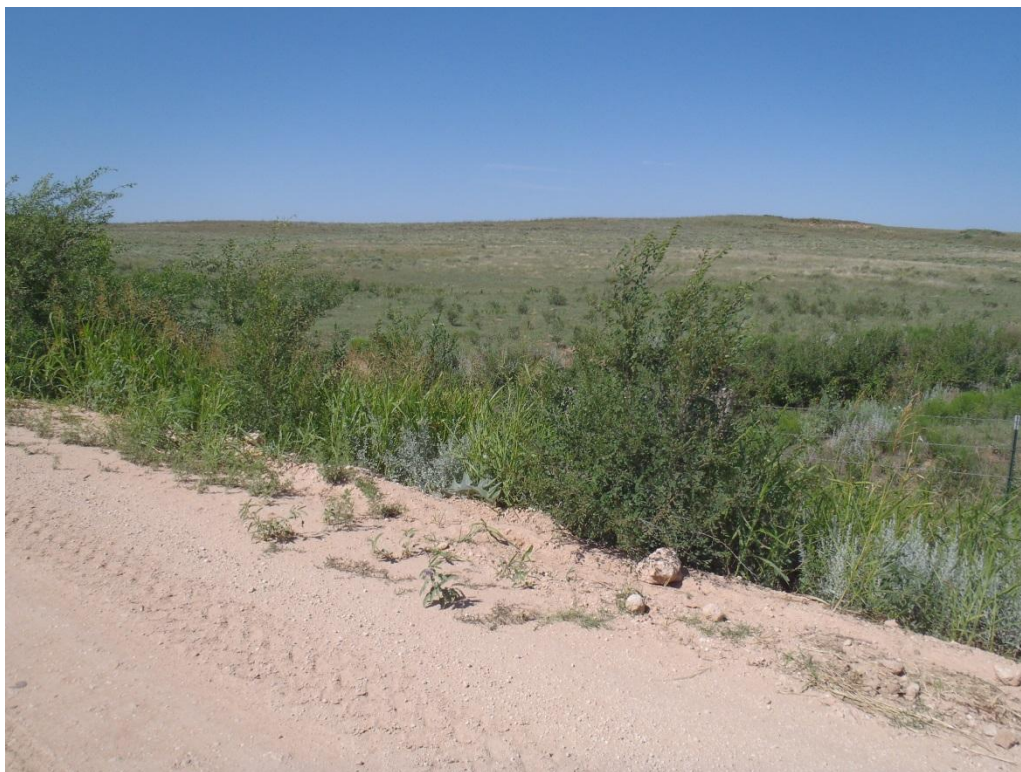
Sweetwater Creek at site SW030 was visited on May 27 and July 28, 2013. This site, located northwest of Mobeetie, Texas in Wheeler County, was accessible through private land that was fenced. With landowner permission, TIAER personnel parked along the county road and stepped through the property fence to conduct the survey. The road crossing served as the 0-m transect and TIAER personnel worked upstream from the road. Although the site is listed as being publicly accessible, public access is limited to an area approximately eight feet up and downstream of the culvert crossing to the property fence (Figure 5.74).

Figure 5.74 Photograph of Sweetwater Creek Site SW030 taken on July 28, 2013 showing public accessibility at the road.

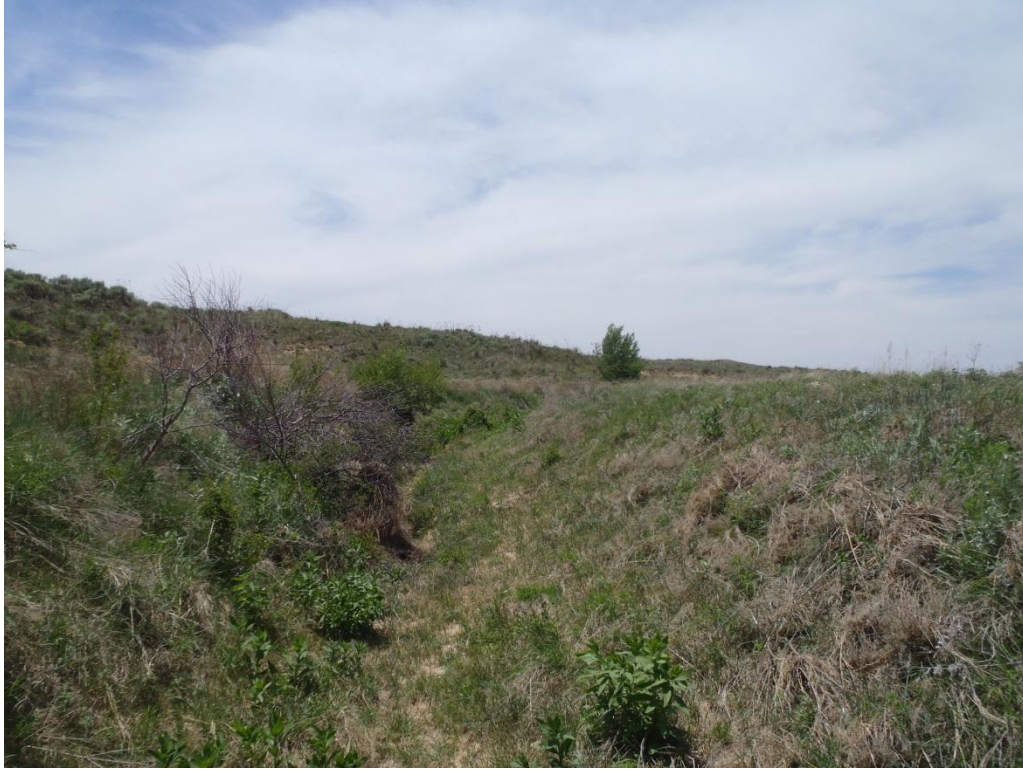
Site SW030 was wadeable for the entire 300-m reach length. No pools were identified during either survey. With no water encountered, the average thalweg for both surveys was 0.0 m (Table 5.6). During both surveys, the sand dominant substrate made traversing the stream channel easy. Maximum and minimum widths of the stream were 0.0 m since the stream was dry (Tables 5.7 and 5.8). The only obstructions encountered throughout the reach were the property fence and the culvert bridge crossing on County Road 2.

Figure 5.75 Photograph of Sweetwater Creek Site SW030 taken on May 27, 2013, the upstream view of the 300-m transect.

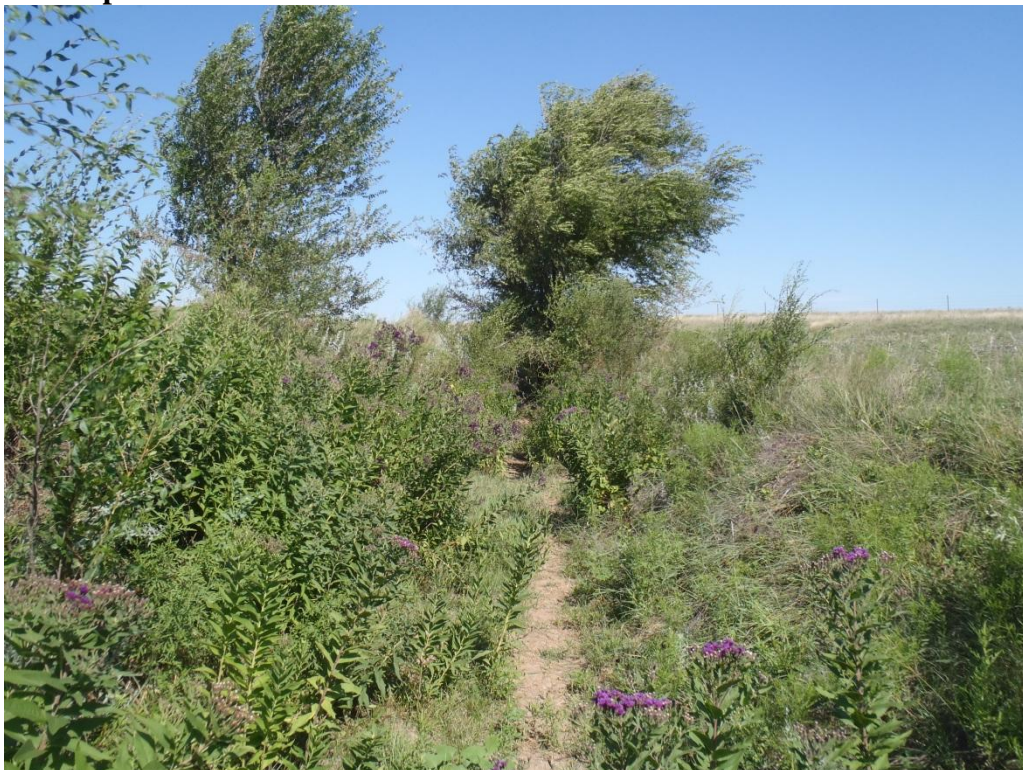
Figure 5.76 Photograph of Sweetwater Creek Site SW030 taken on July 28, 2013, the upstream view of the 150-m transect.

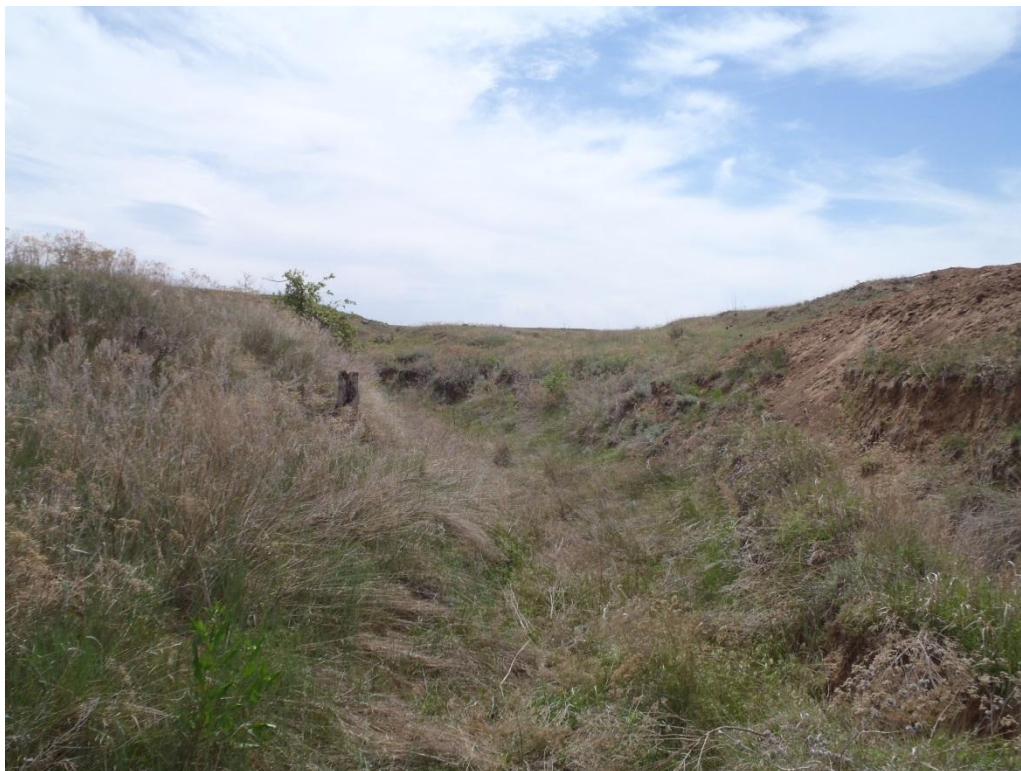
Figure 5.77 Photograph of Sweetwater Creek Site SW031 taken on May 27, 2013, the upstream view of the 300-m transect.

Site SW031 was wadeable for the entire 300-m reach length, although no water was encountered during either survey. No obstructions were encountered within the reach. During both surveys, the sand dominant substrate made traversing the stream channel easy. No pools were identified during either survey. Average thalweg for both surveys was 0.0 m (Table 5.6). Maximum and minimum widths of the stream were 0.0 m since the stream was dry (Tables 5.7 and 5.8).

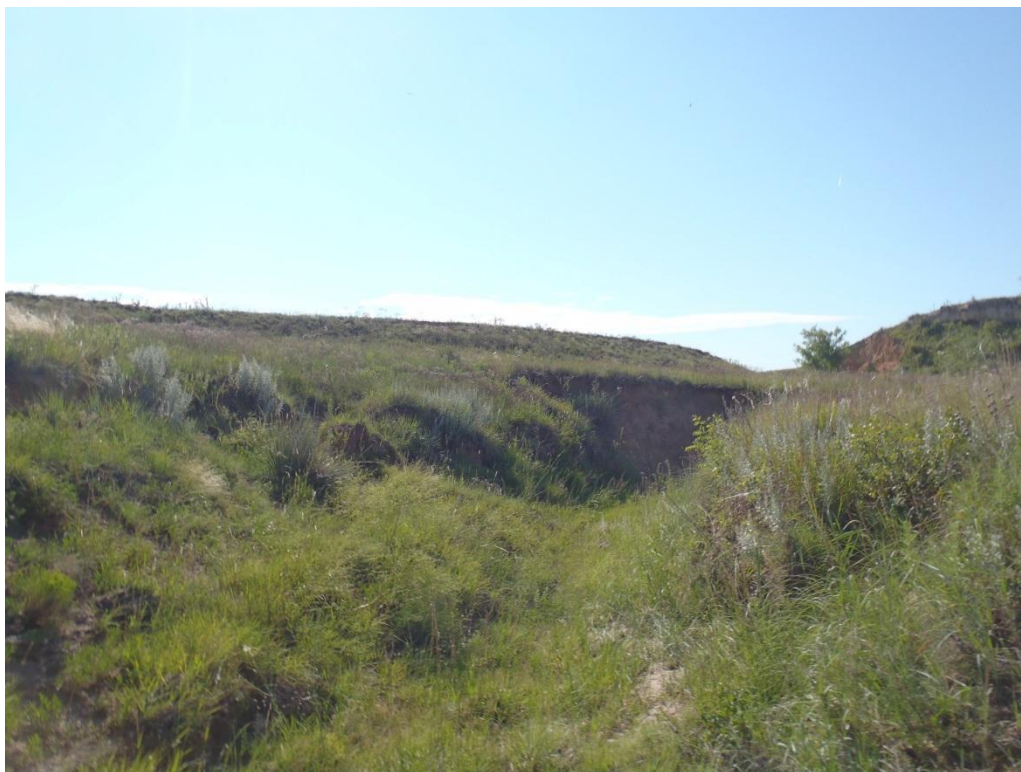
Figure 5.78 Photograph of Sweetwater Creek Site SW031 taken on July 28, 2013, the upstream view of the 30-m transect.

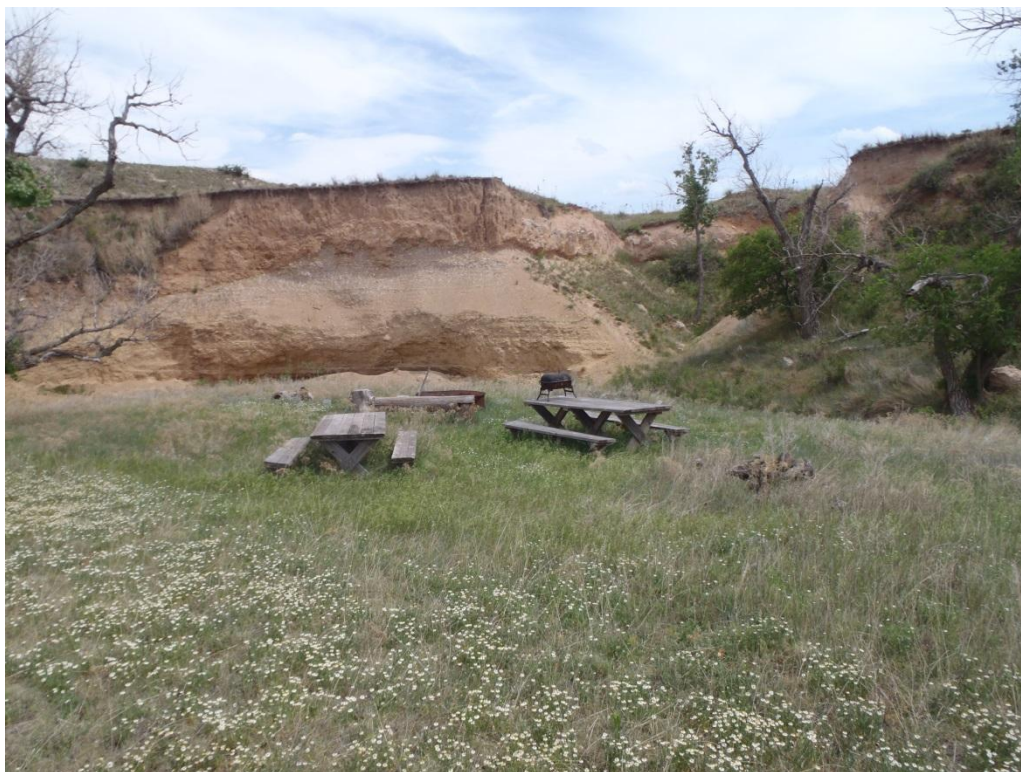
Figure 5.79 Photograph of picnic area between Sites SW031 and SW032 taken on July 28, 2013.

Aesthetic appearance of the water and wildlife observations for the site during each survey have been previously provided in Tables 5.9 and 5.10, respectively. There was a slight presence of turkeys during the first survey. There were no other mammals or vertebrates encountered during either survey. Tracks found during both surveys were identified as canine, cattle, and deer. Bird, canine, and deer feces were found throughout the reach during both surveys. Trash, which was rare, consisted of one metal drum. There was no evidence of human activity was found within the study reach. As previously mentioned, a picnic area was observed on the property between Sites SW031 and SW032.

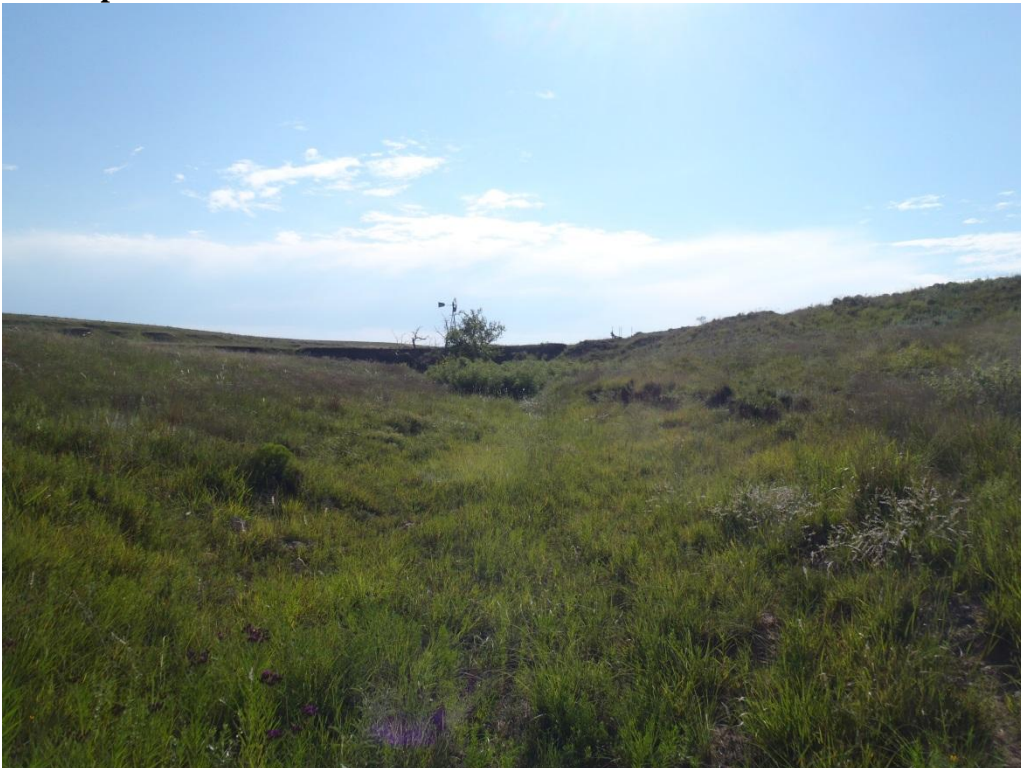
Figure 5.81 Photograph of Sweetwater Creek Site SW032 taken on July 28, 2013, the downstream view of the 150-m transect.

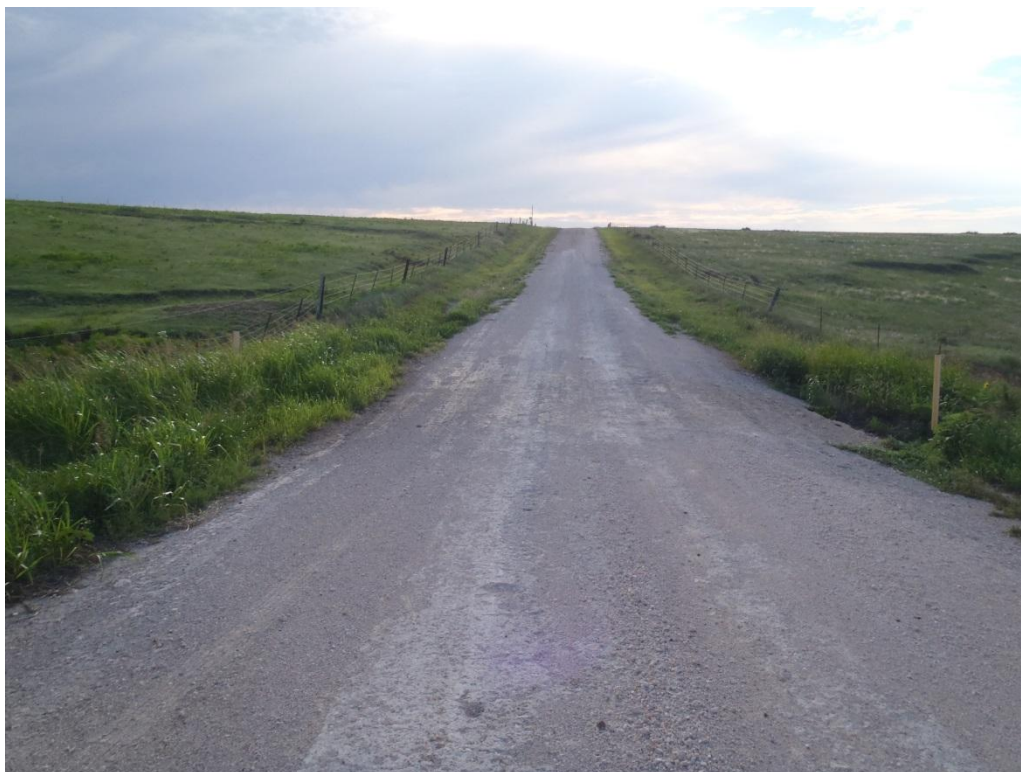
Figure 5.82 Photograph of the road crossing on County Road B (Hoffer Road) at Site SW033 taken on July 28, 2013 showing limited public accessibility.

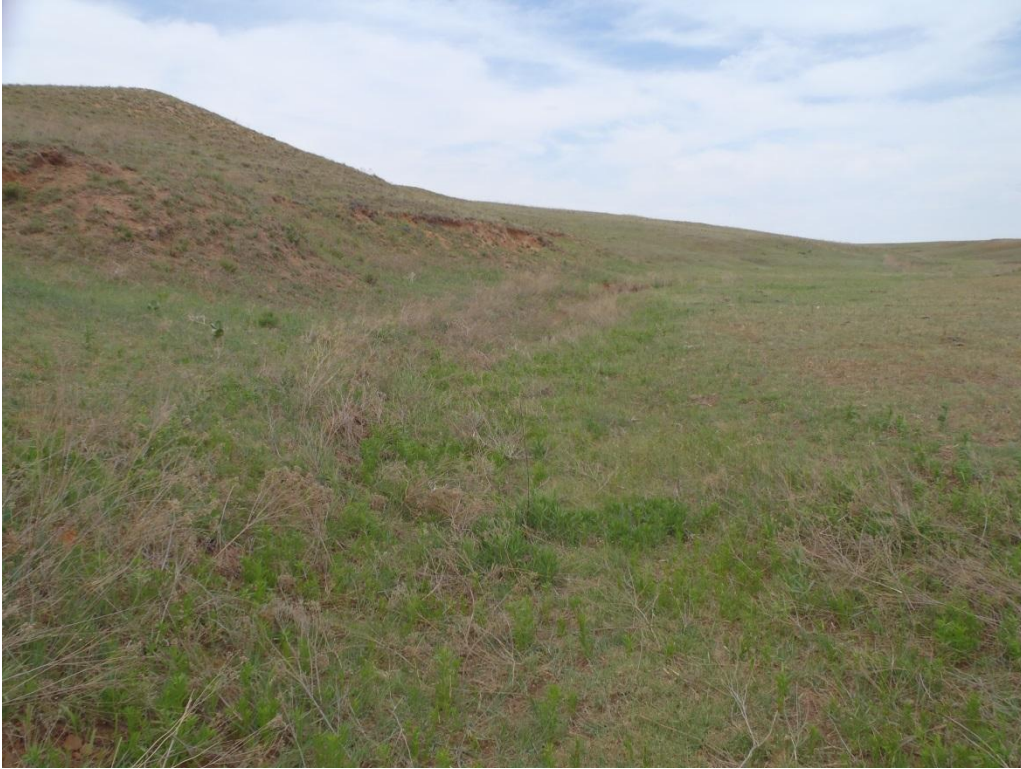
Figure 5.83 Photograph of Sweetwater Creek Site SW033 taken on May 27, 2013, the upstream view of the 150-m transect.

Site SW031 was wadeable for the entire 300-m reach length. No pools were identified during either survey, although pockets of water were encountered during the second survey. Average thalweg was 0.0 for the first survey and 0.02 m during the second survey (Table 5.6). During the first survey, the dry mud/clay dominant substrate made traversing the stream channel easy. During the second survey, the wet mud/clay made wading challenging, but TIAER personnel would walk along the banks of the stream and take measurements and photographs at each appropriate transect. Maximum width of the stream was 3.4 m during the second survey and 0 m during the first survey. The minimum width was 0.0 m encountered during both surveys (Tables 5.7 and 5.8). The only obstructions encountered during both surveys were the property fence and the culvert road crossing. The stream was not flowing during either survey.

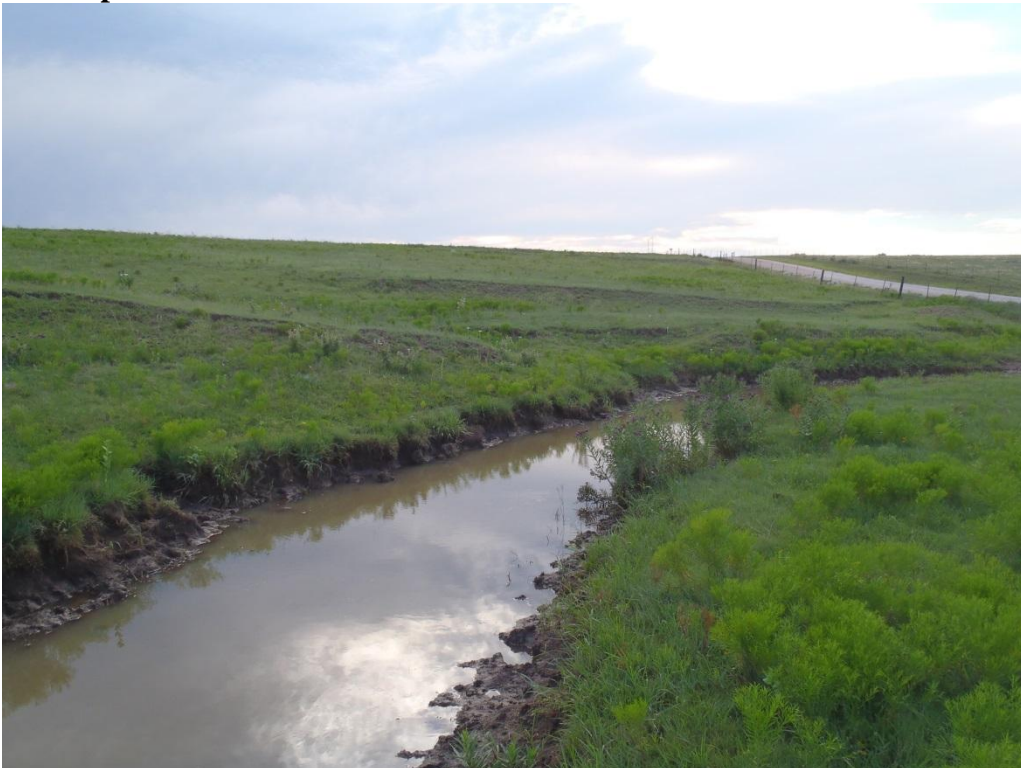
Figure 5.84 Photograph of Sweetwater Creek Site SW033 taken on July 28, 2013, the downstream view of the 30-m transect.

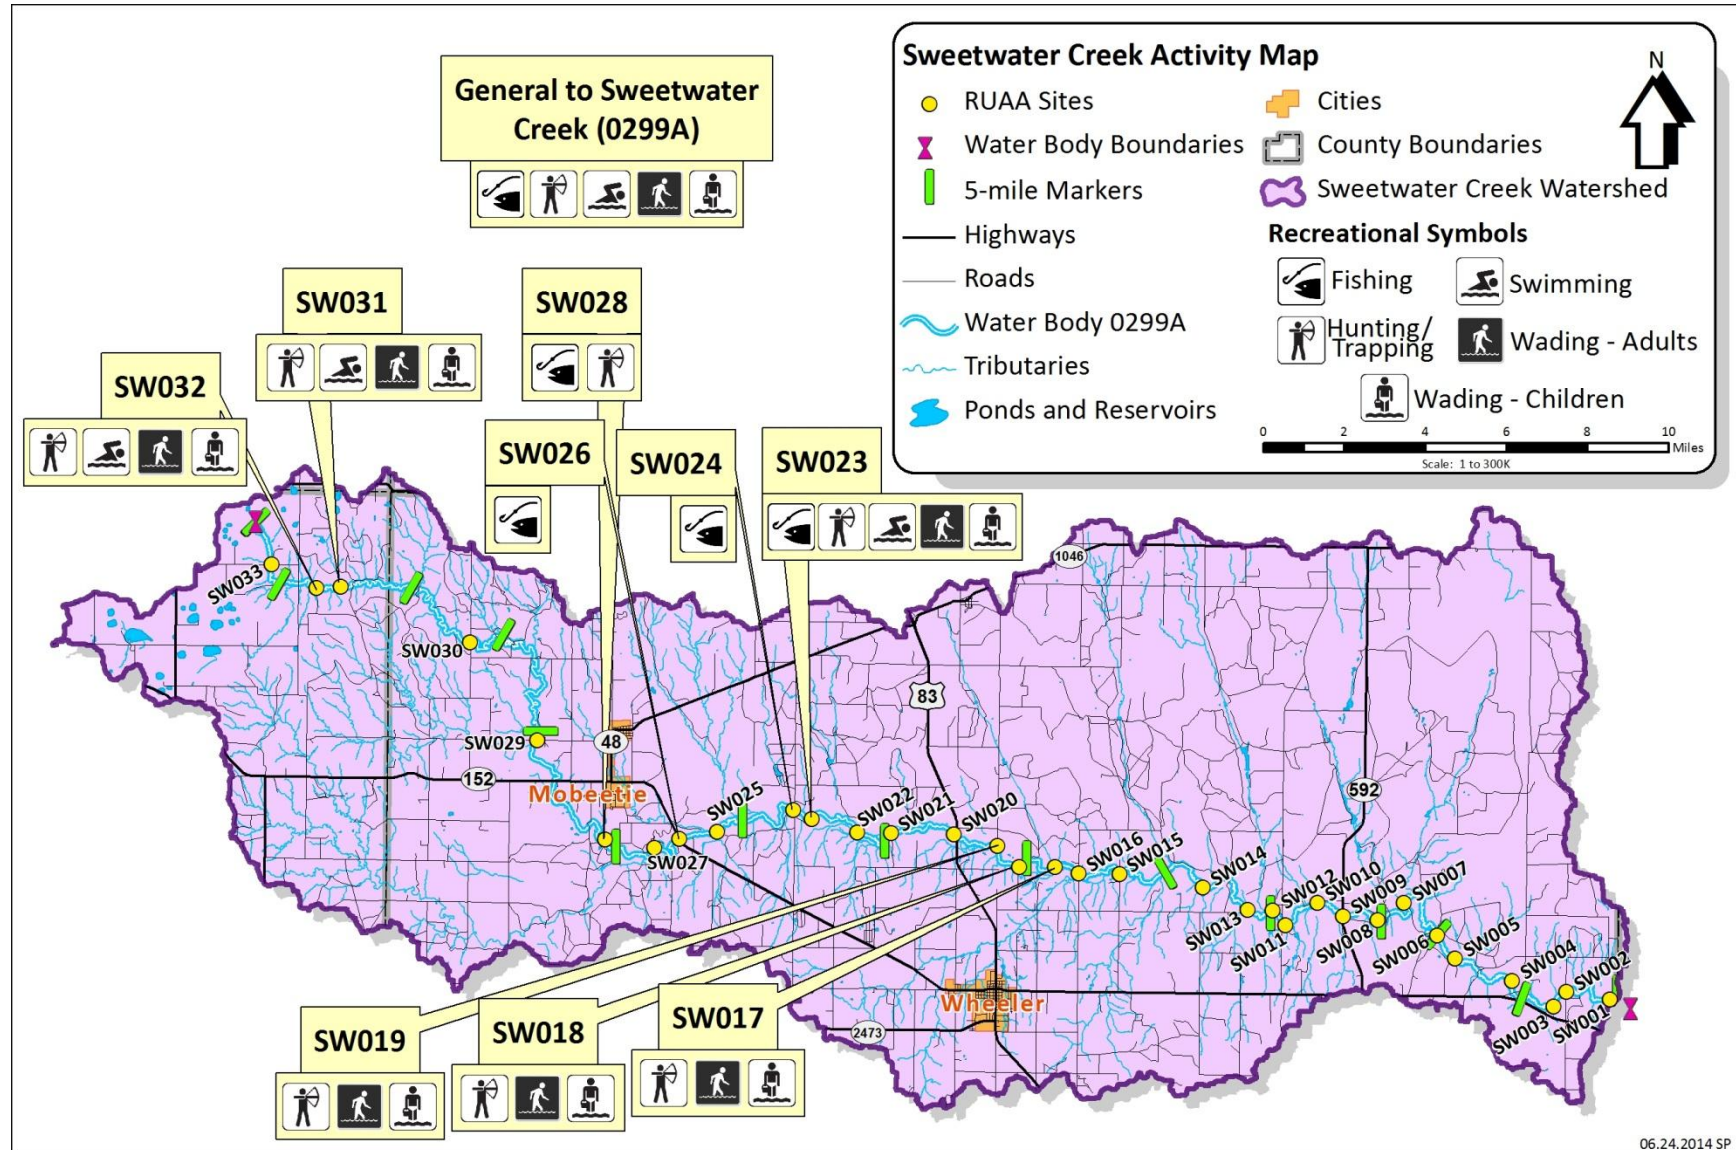
During the two surveys, there were no contact recreational activities observed by TIAER field staff. Additionally, there were no non-contact recreational activities observed during either survey. Interviews revealed that swimming, adult wading, children wading, hunting and fishing has occurred at various sites throughout the reach, although not frequently. Areas of the stream open to the public are limited to the right-of-ways immediately underneath bridge crossings or areas immediately up and down stream of culvert crossings, typically ranging from 5 to 20 meters. Recreational activities reported by interviewees are summarized in Figure 5.85. Overall RUAA findings are summarized in the form below.

Figure 5.85 Summary of observed and interviewed human activities on Sweetwater Creek.
